### A.13: Refurbishing of x-ray mirror by capacitively coupled RF plasma

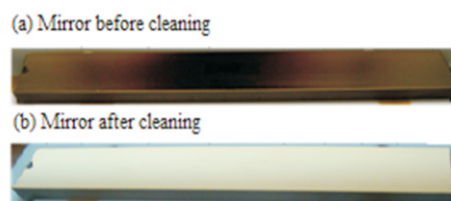
Under the influence of soft x-ray/vacuum ultra violet (VUV) radiation growth of carbon contamination on optical elements in a synchrotron beam line is a known problem. The carbon contamination layer causes severe absorption near the carbon K-edge and also increases scattered background, consequently the efficiency of reflection and monochromatization decreases particularly in the soft x-ray/vacuum ultra violet region. The carbon layer causes destructive interference and affects photon beam intensity in high energy region as well. The photon flux loss due to carbon contaminations has forced to search suitable technique to remove contamination layer and restore the optical surfaces. Synchrotron optics require extremely precise coatings on premium quality substrates, these substrates and coatings can be very expensive, so it is desirable to refurbish the contaminated optics by suitable carbon removal technique. In present work we refurbished carbon contaminated gold coated toroidal pre-mirror of reflectivity beam line (BL-04 at Indus-1) by an in-house developed capacitively coupled RF plasma cleaning setup developed at Laser Plasma Section. Photograph of the mirror before and after RF plasma cleaning is shown in Figure A.13.1. Before cleaning the actual mirror in the system, RF power, exposure time and process gas pressure of the system was optimized using test samples (Si-substrate/Pt (450Å)/C (300 Å)) and it is observed that 10 W (33.3 mW/cm<sup>2</sup>) power is suitable for removing 30 nm carbon film in 30 min without affecting roughness of the surface. The samples to be cleaned were kept at the bottom electrode keeping the contaminated surface in vertical plane in order to avoid ion sputtering from the reflecting surface. The contaminated mirror was exposed to RF plasma at 10 W powers for one hour. During the exposure experiment, the emission lines of CO and CO<sub>2</sub> was continuously recorded by a fiber based optical spectrometer.

Fig. A.13.1: (a) Synchrotron radiation induced carbon contaminated mirror (size 340mm x 60mm x 40mm) (b) After carbon removal by RF plasma at 10 watt power for 1 hour.

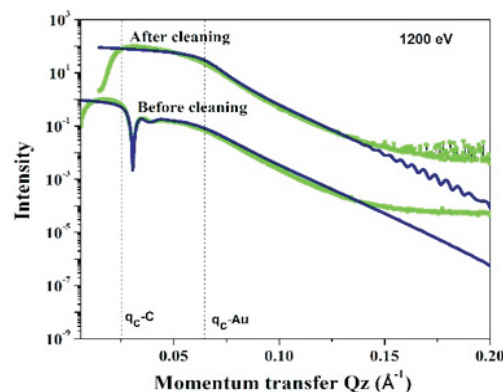
Measured and fitted SXR patterns, before and after cleaning the mirror are shown in Figure A.13.2. A clear dip before the critical momentum of gold in reflectivity patterns of contaminated mirror indicates the presence of carbon contaminated layer. The layer density and optical constants are obtained by fitting of measured data. During the SXR fitting, thicknesses and interface roughnesses of C, Au and Cr layer and optical constants of C layer kept as free parameters whereas optical constants of Au and Cr layer are kept constant. The energy dependent optical constants values are taken from Henke data base. The contamination layer thickness, roughness and density was found to be 400 Å, 60 Å and 75% of graphitic carbon density, respectively. The disappearance of a dip in the reflection patterns just before the gold critical momentum indicates that the carbon layer is removed after the exposure of the mirror in the RF plasma.

Fig. A.13.2: Soft x-ray reflectivity patterns before and after cleaning the contaminated mirror are shown.

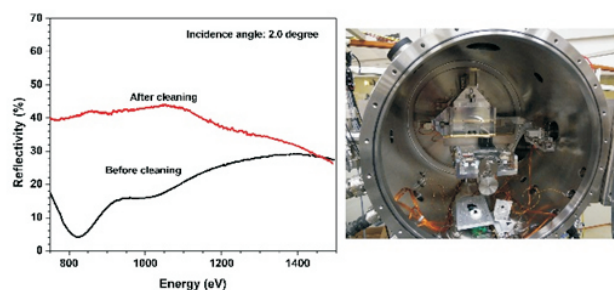
Fig. A.13.3: (a) Soft x-ray reflectivity performance in 750 to 1500 eV energy region measured before and after RF plasma cleaning at 2 degree incidence angle (b) View of reflectometer (at BL-3, Indus-2) with mirror mounted for soft x-ray reflectivity test.

Energy dependent reflectivity pattern of contaminated mirror measured in 750 to 1500 eV photon energy region is shown in Figure A.13.3 along with inside view of the reflectometer with the mirror mounted for the test. It is found that the reflectivity performance is regained after the carbon layer removal using the RF plasma technique. In summary we successfully refurbished a synchrotron mirror using capacitively coupled RF plasma.
