## **L.1: Removal of coolant channel and cutting of thick end fitting inside lead shielding flask at KAPS-1**

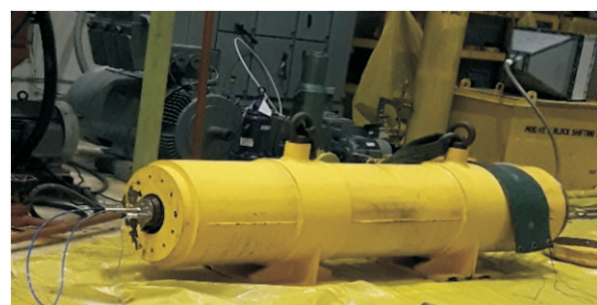
The total length of inboard end fitting along with PT was large to be handled in hot cell for PIE. Thus, cutting of inboard end-fitting near roll joined area, at a distance of ~1100 mm from its face, where the thickness of end fitting was 18 mm, was required. The tube had a radiation field of about 7000 Rad/hr. and cutting was required to be done from inside the tube, remotely in a closed lead shielding flask blindly. This was a challenging task. Remotely operable laser cutting tools for inboard liner tube and end fitting near rolled joint area was developed along with laser cutting technology for 18 mm thick end fitting in single pass. Online monitoring of cutting from inside of the flask was also developed to visualize the status of cutting operation. This remotely operated laser based cutting technology for cutting of highly radioactive end fitting in shielding flask was deployed successfully for the first time with minimum radiation dose consumption. This laser cutting operation was completed in a very short time span of ~2 hours without any airborne activity or radiation hazard. Debris generated during laser cutting process was passed through a HEPA filter. After this activity, cracked/leaked portion of pressure tube of Q-15 has been sent to BARC for PIE and analysis. Figure L.1.1 shows laser cutting fixture for cutting of 18 mm thick end fitting and Fig. L.1.2 shows laser cutting of 18 mm thick end fitting in lead shielding flask.

*Fig. L.1.2: A view of laser cutting of 18 mm thick end fitting in lead shielding flask*
